Mapping and Interpreting the Armory Tailrace at Harpers Ferry National Historical Park

J.P. Ebersole

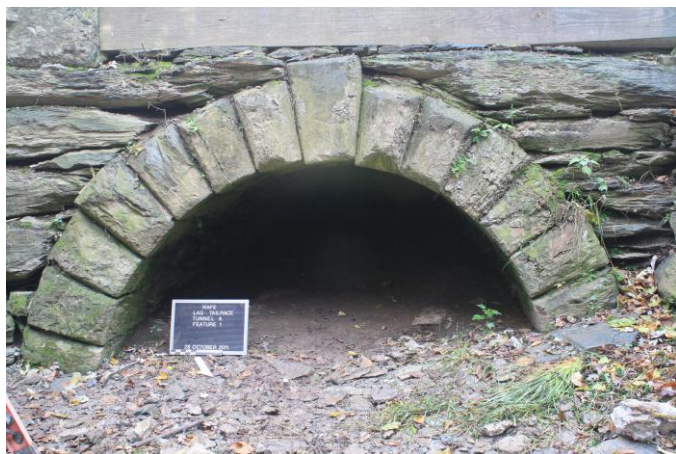
The entrance to the tailrace tunnel as it appears today. Historically, this would have been the exit point for the water that had passed through the waterwheel. Sedimentation from reoccurring floods and gradual erosion have reduced the size of the opening to only 3 ft. in height.

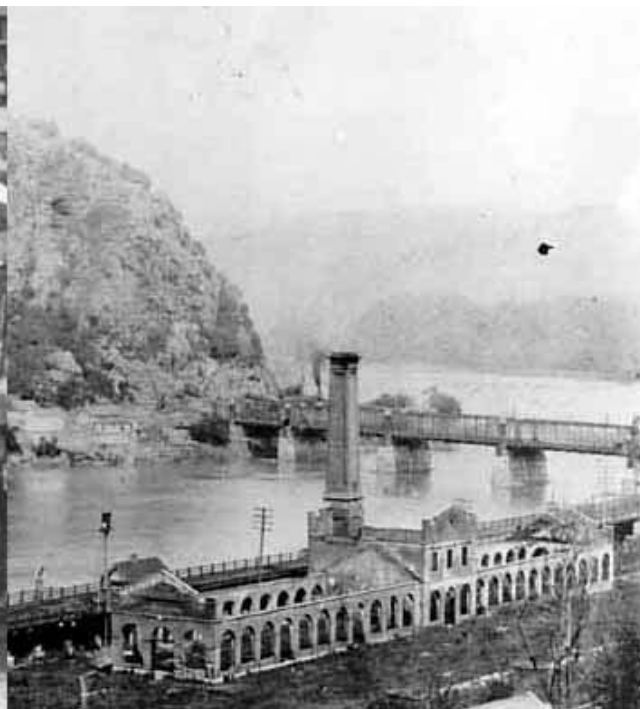
LEFT: The arrow points to the exit point of the tailrace tunnel within the river wall bordering the Potomac in this photograph of the remains of the Smith & Forging Shop smoke stack circa 1890 (NPS Collection HF 1155). RIGHT: A view of the remains of the Smith & Forging Shop looking east as taken on May 29, 1886 (NPS Collection HF 0752).

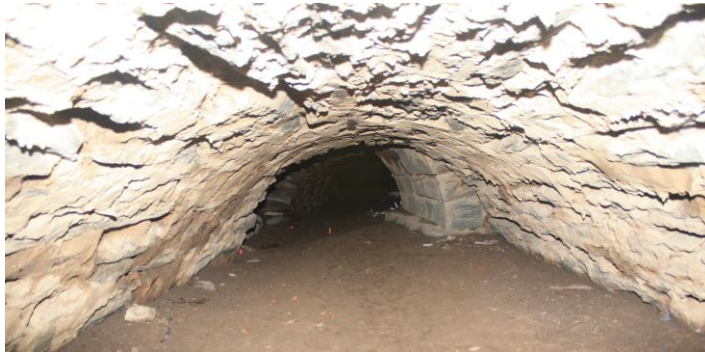
This image shows how the tailrace appears just inside of the riverside entrance. The disjunction between the various sections of the tunnel is clearly visible here. These changes delineate different construction phases.

The tunnels were constructed as a series of arched vaults that document the complex evolution of the tailrace. Rough-hewn shale is the predominant construction material for both tunnels, owing to its abundant occurrence as natural outcrops throughout Harpers Ferry. There are, however, three instances of the use of brick for vaults. One of these brick vaults was used simply to enable the aforementioned curve in the secondary tunnel. The remaining two, on the other hand, correspond to the actual locations of former Armory shops. Specifically, the brick vault in Tunnel A was situated beneath the Polishing Shop, while the straight vault in B ran beneath the Finishing Shop. The former shop was so named because it contained stones for grinding and polishing musket barrels. Workers in the latter shop turned and finished barrels through the use of lathes and other devices.

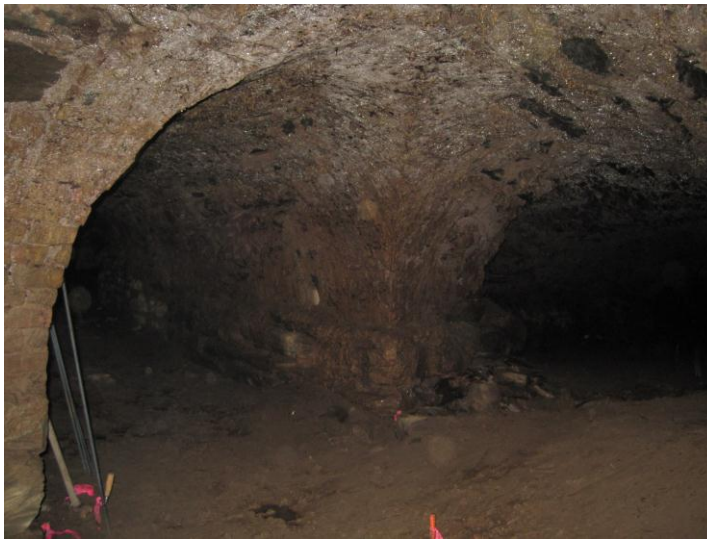
The "Y" intersection with Tunnel B on the left and Tunnel A on the right.

Exploration of the tunnel revealed a number of fascinating construction features. NPS archeologists found that the tunnel is not simply a single shaft but is, in fact, comprised of two sections forming something of a "Y" shape. The main shaft (Tunnel A) extends 183 ft. from its river side opening to a point where the B&O Railroad crew intentionally collapsed it as part of their 1892-94 berm construction. As for the secondary shaft (Tunnel B), it runs an additional 70 ft. from its intersection with the main tunnel at 86 ft. until it, too, ends at a deliberate collapse. Unlike the main shaft, though, this secondary tunnel has a curved portion facilitating its junction with the larger tunnel.

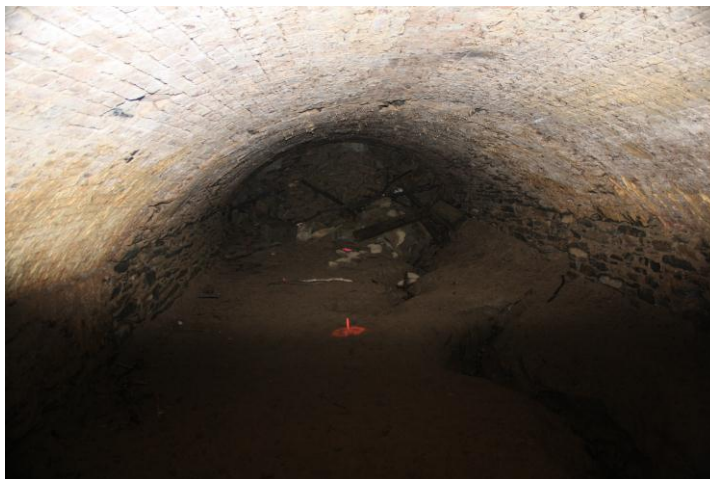
The largest chamber of Tunnel A. The vault in the foreground is brick while the rear vault is shale. At the end can be seen the intentional collapse from the B&O Railroad berm construction in 1892 through 1894.

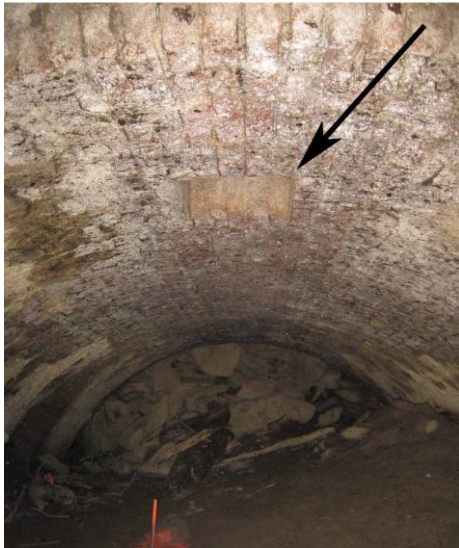
The arrow points to the location of the drain hole in the last chamber of Tunnel B. In the background can be seen the intentional collapse and backfill from the 1892-1894 B&O Railroad berm construction.

Indirect evidence of that machinery in the form of three drains were discovered in the ceilings of the tunnels. In Tunnel B a 1 ft. square hole capped by a perforated shale block most likely allowed excess water to drain into the raceway. In Tunnel A, two 0.46 ft. square drains on opposite sides of the vault contain copper gutters that directed water away from at least two independent polishing machines.

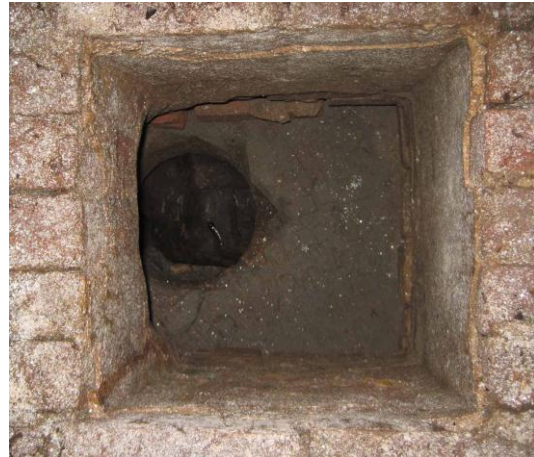
The large drain hole feature in the ceiling of Tunnel B.

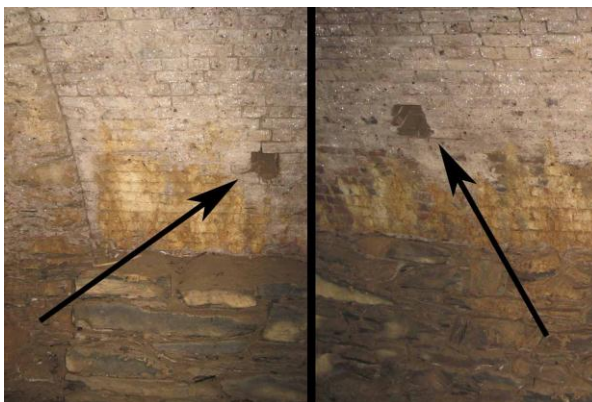
These two photos show the drains in Tunnel A. On the left is the eastern wall while the right side displays the western wall.

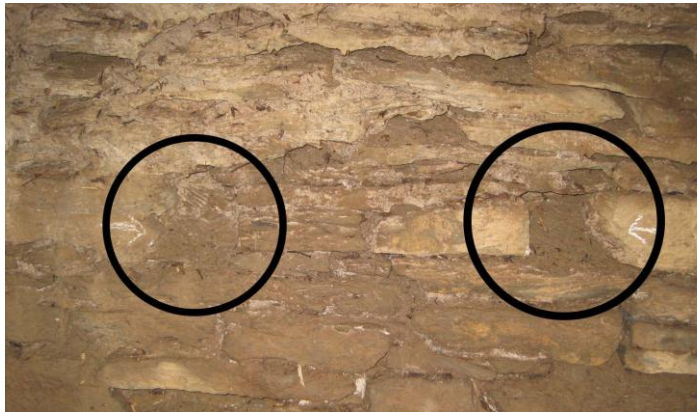
Two beam voids within the western wall of Tunnel A.

Multiple beam recesses were also noted in the walls of Tunnel A during mapping. Most are situated in the shale walls of the largest chamber two feet above the current floor surface. Forming a series of twelve paired cavities, these suggest that wooden beams 16 ft. in length once spanned this portion of the tunnel for 25 ft. of its length. Plaster remnants in individual recesses clearly show the wood grain of the beams. Their purpose at this location appears directly related to an above ground bridge depicted on a map dated to 1803. Since the original tailraces were not vaulted, a bridge was necessary to connect the shops and allow for armorers to cross the channel.

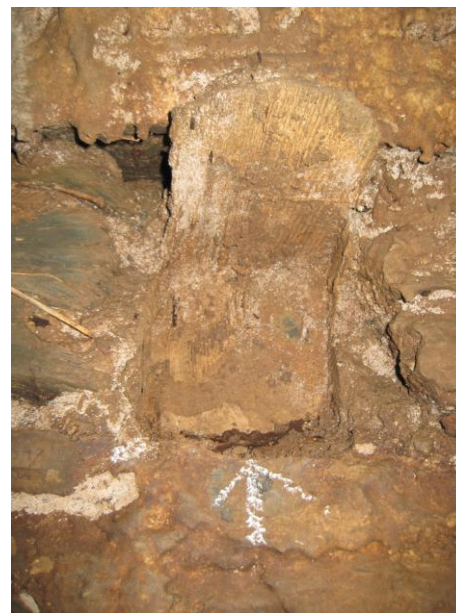
A detail view of one of the beam voids showing plaster that once encased the end of the wooden beam. The impression of the wood grain is still visible today.

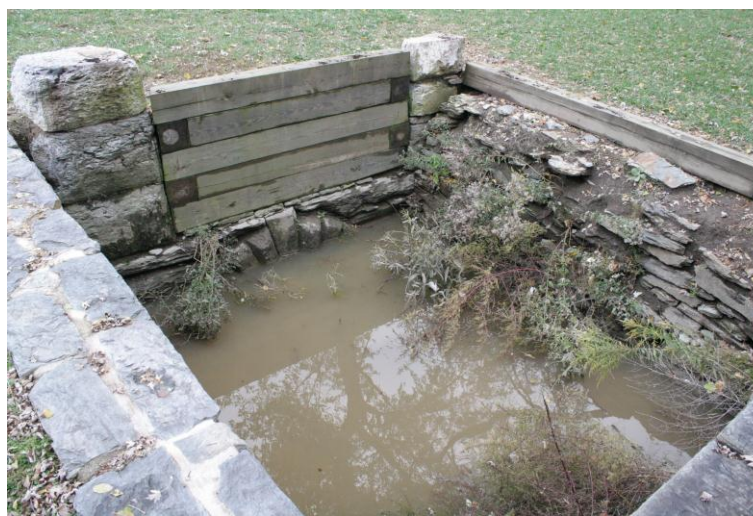
The tailrace culvert as it appeared just after Hurricane Sandy in 2012. The archway is visible just above the water line in the center of the photograph. Repeated inundations have silted in other tunnel entrances preventing their documentation.
